NSWCCD-61-TR-2003/09 September 2003

Survivability, Structures, and Materials Directorate
Technical Report

Spray Forming Iron Based Amorphous Metals

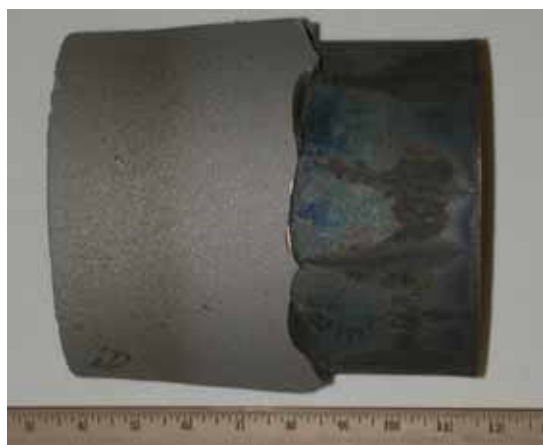
Figure 4: Tubular Run 523 - DAR1A

All of the spray formed deposits to date have had severe cracking during the slow cooling phase of the process. In the case of the tubular substrates, this has caused material to fall off of the substrate after spray forming is complete. Examples of cracking in the tubular and flat plate runs are shown in Figures 4 and 5 below. Possible causes for these cracks and spalling are thermal mismatch at the substrate/deposit interface and/or thermal stresses built up within the deposit due to rapid cooling. It is also noted that these alloy compositions are particularly brittle in their ingot form as well - all ingots received to be melted from INEEL were broken into several pieces and could be easily fractured on impact with a conventional hammer.

As previously mentioned, after each of the spray forming runs, the material cracked (Figures 4 and 5). Most of the fracture surfaces had a very brittle appearance without signs of any plasticity (Figure 14). However, the fracture surface (Figures 15 and 16) from Run 537, DAR35 had some signs of plasticity. It indicates the potential for this material to exhibit plasticity in mechanical property tests. Additional spray forming runs with DAR35 are planned, and the material will be used for tensile strength tests.

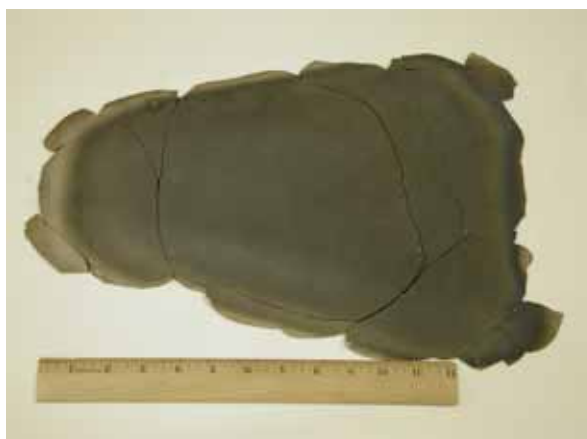
Figure 5: Flat Plate Run 532 - DAR27

In Run 537 a titanium substrate was used in an effort to minimize cracking. Run 537 had less cracking than previous runs, but still cracked.

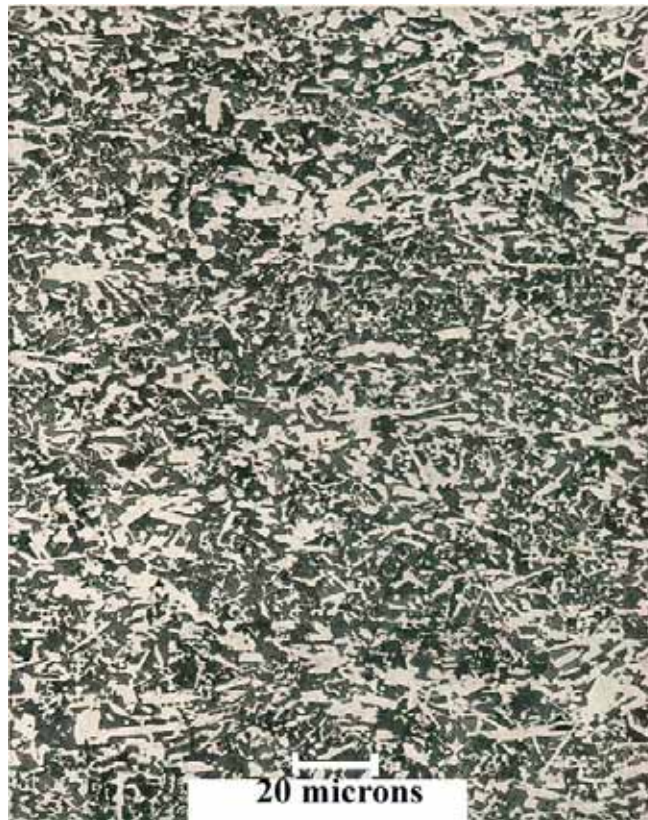
Figure 17. Optical Microscope Image of DAR35, Run 537, Etched.

Samples from all of the spray formed runs were examined with the optical and scanning electron microscopes. The microstructures from Run 537, DAR35 was especially interesting. The optical microscope image is shown in Figure 17, and the scanning electron microscope, backscattered electron image (BSE) image is shown in Figure 18. In both figures three major phases are evident. For comparison purposes it should be noted that the white phase in the optical image appears light gray in the BSE image, the light gray phase in the optical image appears dark gray in the BSE image, and the dark gray phase in the optical image appears white in the BSE image. These phase equivalences between the optical and BSE images are also given in Table 6. An EDXA analysis on the SEM was used as an aid in identifying the elemental distribution in the phases. In Figure 17, the dark gray phase is a complex carbide of iron, molybdenum and chromium with some boron, silicon, and tungsten; the light gray phase is rich in iron and silicon with lesser amounts of the other elements; and the white phase is rich in iron, chromium, with lesser amounts of the other elements. Further work is needed to determine which of these phases is/are still amorphous.

The composition of DAR35 is a higher silicon version of DAR27. DAR35 has 5 at. % silicon versus 1 at. % for DAR27 with the other alloying additions held the same. This difference in silicon created a marked difference in the microstructure of the two alloys. Optical and scanning electron microscope images for DAR27, Run 532 are shown in Figures 19 and 20. In comparing the BSE images (Figures 18 and 20), it appears that DAR35 has more carbides (the white phase) and more of a dark gray phase. EDXA of the phases in Figures 18 and 20 showed a composition difference in the dark gray phases in the images. Specifically, the dark gray phase in the BSE image of DAR35 (Figure 19) is silicon rich; the dark gray phase in the BSE image of DAR27 (Figure 20) is not silicon rich. There is also a morphological difference in the light gray phase in each of the images. In DAR35 the light gray phase is more needle-like.

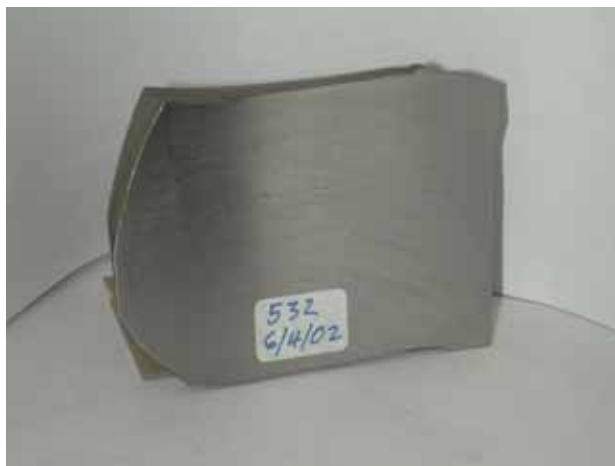
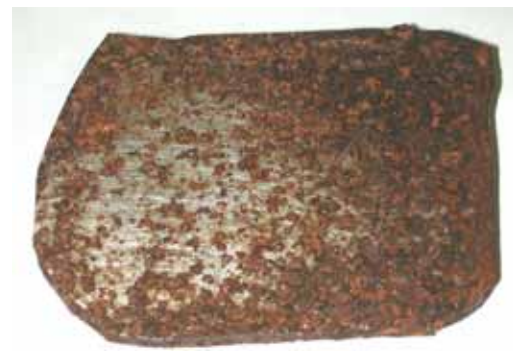
Figure 22. Photographs of Salt Fog Corrosion Samples of DAR27, Run 532 Before and After Exposure.

After exposure for 24 cycles (1000 total hours) in the salt fog chamber, all of the samples showed extensive corrosion in the form of rust. Since all of the samples were partially devitrified and contained ferrite, the rust was to be expected. The extent of the rusting was similar to that for an unpainted hull steel, such as HSLA 80. Before and after photographs of the samples of DAR1A and DAR27 are given in Figures 21, and 22, respectively. A photograph of the sample of DAR35 after 5 cycles is shown in Figure 23. Also shown in Figure 23 are control samples of HSLA 80 and Inconel 625.

22a. Salt fog sample of DAR27, Run 532 before exposure.

22b. Salt fog sample of DAR27, Run 532 after 7 cycles.
